**FATIGUE BEHAVIOR OF A CROSS-PLY
CERAMIC MATRIX COMPOSITE SUBJECTED TO
TENSION-TENSION CYCLING WITH HOLD TIME**

THESIS

Scott A. Grant
Captain, USAF
AFIT/GAE/ENY/94D-16

AIR FORCE INSTITUTE OF TECHNOLOGY

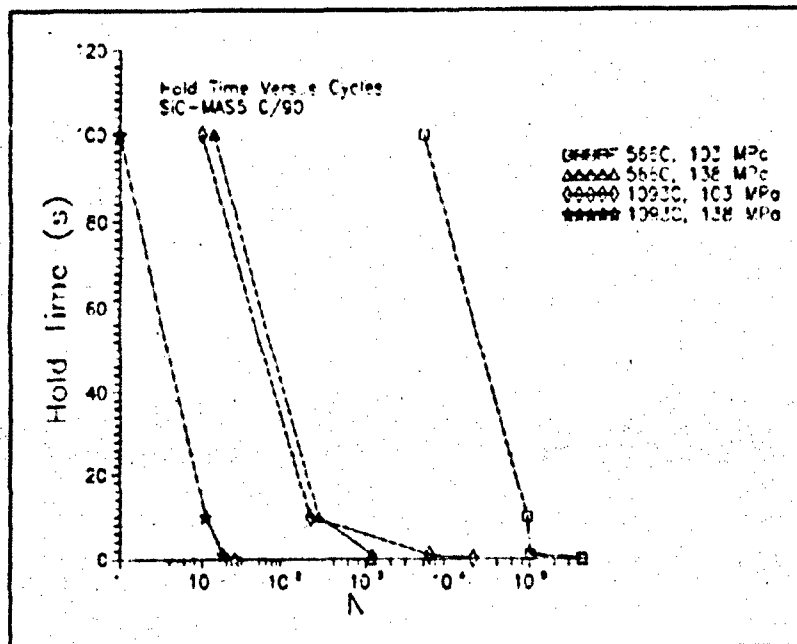
Figure 9. Effect of Hold Time On Life.

Figure 9 illustrates the effect of hold time at both temperatures. It shows that the effect of hold time is to decrease the number of cycles by the same *factor regardless of the stress or temperature*. This implies a strong dependence on the temperature of the oxidizing environment and will be explored further.

Expanding on the results of Figure 9, plots of the specimen stress versus the exposure duration to the high temperature environment were created from the S-N data. In addition to the data from the present study, the stress-rupture data presented by Larsen [3] at 1093°C was also plotted. The exposure duration to the environment was defined as the number of cycles to failure multiplied by the duration per cycle. It was assumed that the exposure began at the start of load application (beyond the minimum specified by the value of R) and ended when the stress returned to the minimum value. For example, if the cycle hold time was one second with a one hertz ramp rate, the total exposure would be two seconds. Figures 10 and 11 illustrate the result of this normalization technique.

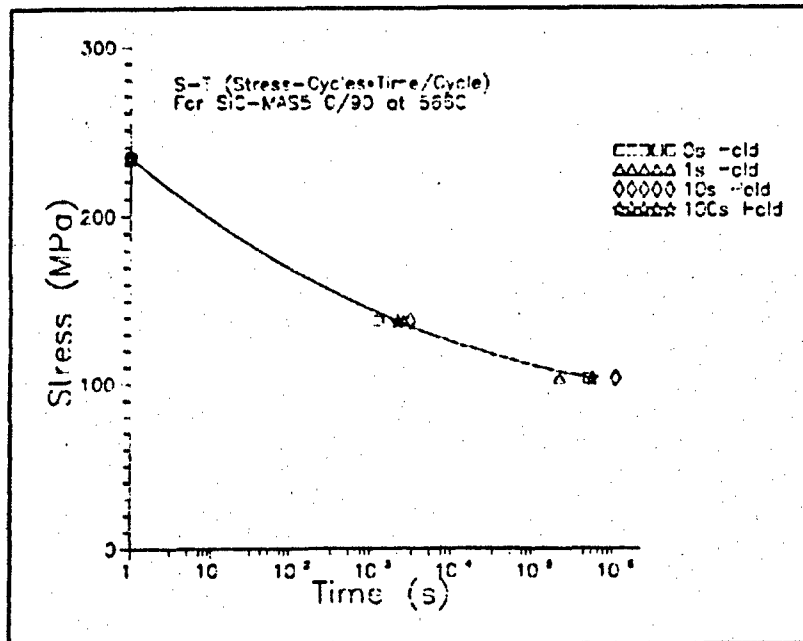
Figure 10. S-T Curves for 566°C.

At 566°C, the S-T data collapses to within a factor of two--a normal scatter in fatigue experiments. In contrast, the spread in the S-N data is approximately the same at both stresses--two orders of magnitude. This reduction of data spread is caused by the normalization technique, that is, the introduction of the exposure time parameter normalizes the data to account for the effect of the environment. The fatigue life of the material at this temperature is almost totally dependent on the exposure time under stress with a negligible effect from the cyclic fatigue.

The differing extent to which the S-T data collapsed at 566°C as compared to 1093°C (as shown in Figures 10 and 11) combined with the dependence of modulus degradation on hold time at low stress implies a combined effect from the cycling and the environment. This differs from the 138 MPa behavior in

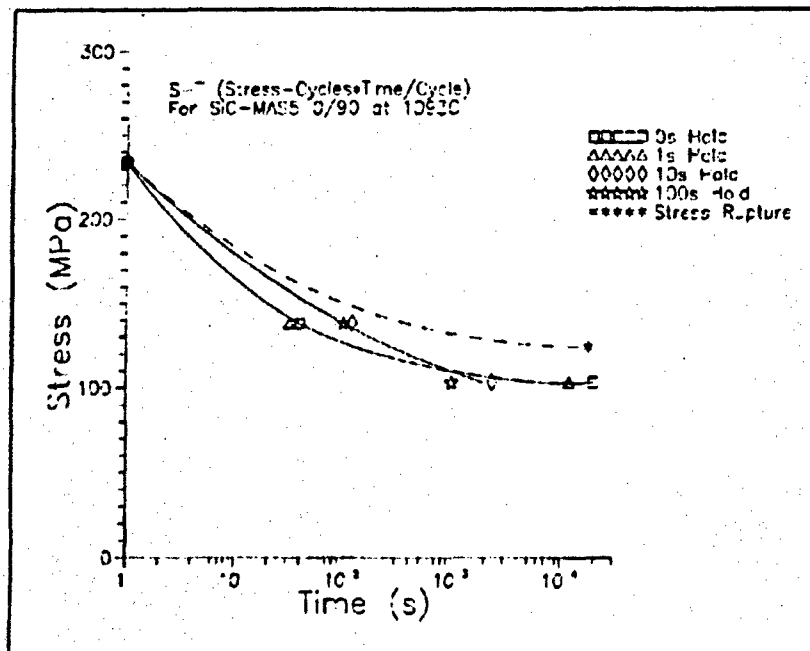
Figure 11. S-T Curves for 1093°C.

In fact, close examination of Figure 11 will reveal differing regions of contribution from cyclic fatigue and the environment. For example, as the stress increases, the curves tend to collapse as in Figure 10. But as the stress decreases, the effect of the cycling increases, causing the data to spread. In addition, the data in Figure 11 have split into three separate curves--one representing the shortest hold times (0 and 1 second), one representing the longest hold times (10 and 100 seconds), and one representing the pure stress-rupture result. The effect of the cycling is largest at the lowest hold times (as evidenced by a lowering of the curve), while the curve representing the longer hold times is closer to the pure stress-rupture result. This follows logically since the longer hold times contain larger stress-rupture components.

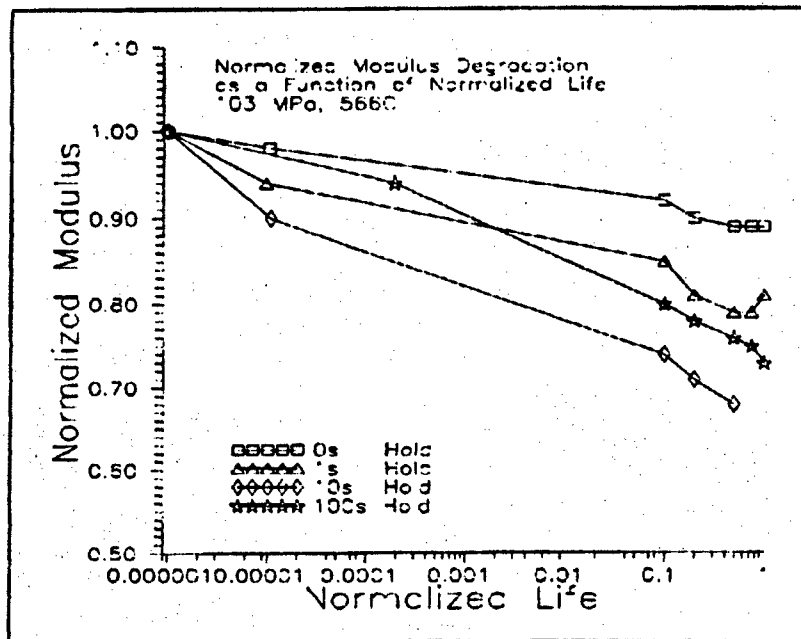
Figure 21. Normalized Modulus Degradation/Life for 566°C, 103 MPa.

At 566°C, the 103 MPa tests show a definite dependence on hold time as shown in Figure 21. In general, as the hold time increases, the extent of modulus

degradation also increases. At failure, the normalized moduli for this combination of stress and temperature vary between 0.7 and 0.9. When the stress is increased to 138 MPa, the normalized modulus stabilizes to approximately 0.6 after the first few cycles as shown in Figure 22.

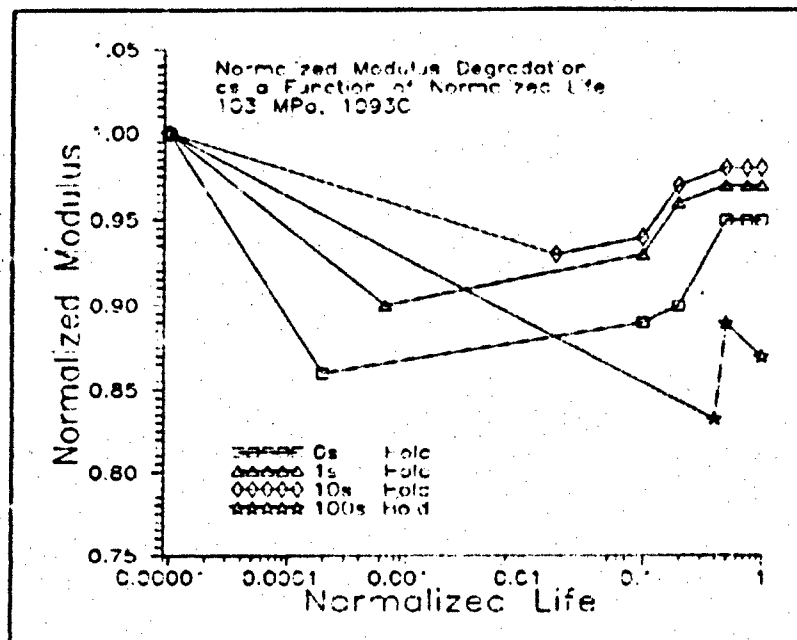
Figure 23. Normalized Modulus Degradation/Life at 1093°C, 103 MPa.

Throughout the tests at this temperature and hold time, the moduli are within 6-8% of one another as shown in Figure 23. This small variation implies that the degradation of the modulus under the high temperature/low stress condition is not a function of hold time. However, the longest hold time of 100 seconds did correspond to the largest modulus decrease. At the higher stress, all normalized moduli fall within the first few cycles to 0.45 to 0.5. Again, as in the low temperature case, the stabilized value of normalized modulus is not dependent

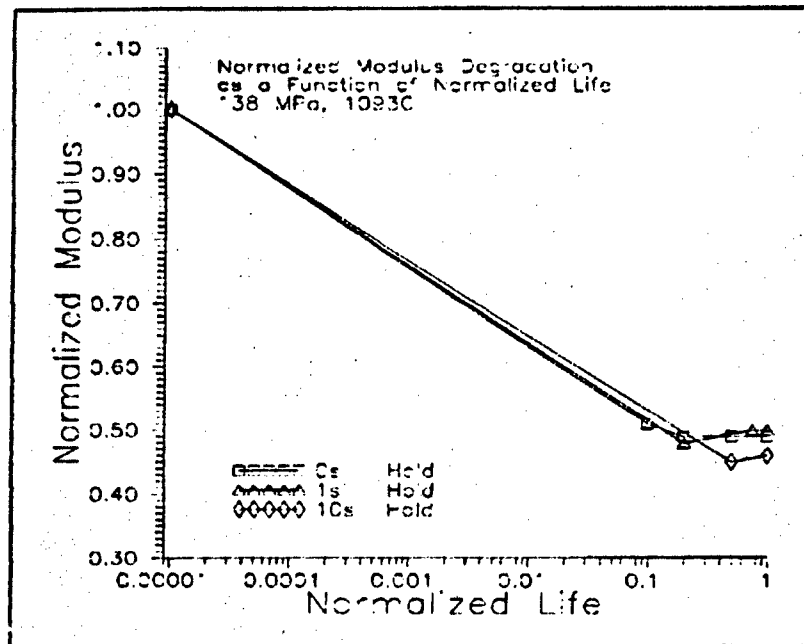
Figure 24. Normalized Modulus Degradation/Life at 1093°C, 138 MPa.

on the hold time. Figure 24 illustrates the trends at this combination of temperature and stress.

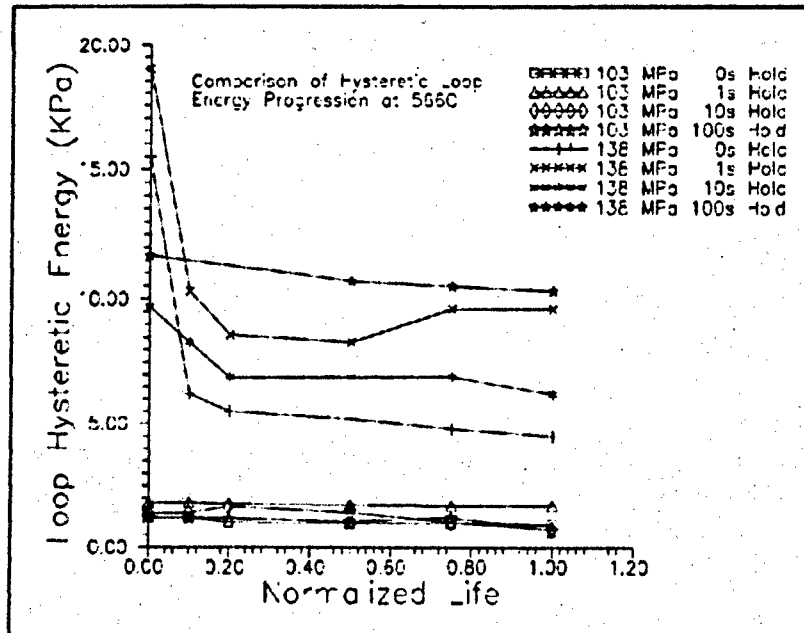
Figure 27. Loop Hysteretic Energy at 566°C.

First, the results were examined on the basis of temperature. At 566°C, 103 MPa, the data is rather random, but all are within 20% of an approximate mean of 1.35 KPa. At 138 MPa, the trend becomes less ambiguous with the longest and shortest hold times resulting in the greatest and least loop hysteretic energy, respectively. These trends are shown in Figure 27. This falls in line with the observations of the moduli reductions. The 103 MPa modulus reductions were small and within 10% of an approximate normalized modulus of 0.9 while the 138 MPa reductions were far greater at a normalized modulus of approximately 0.6. In fact, the 33% increase in stress from 103 MPa to 138 MPa resulted in an increase of approximately 500% in the value of loop hysteretic energy and a degradation increase of 50% at a given normalized life.

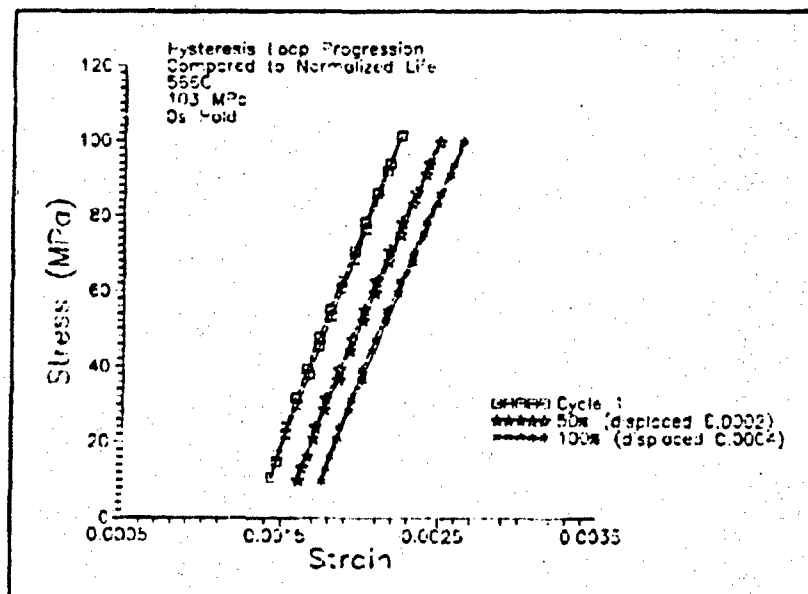
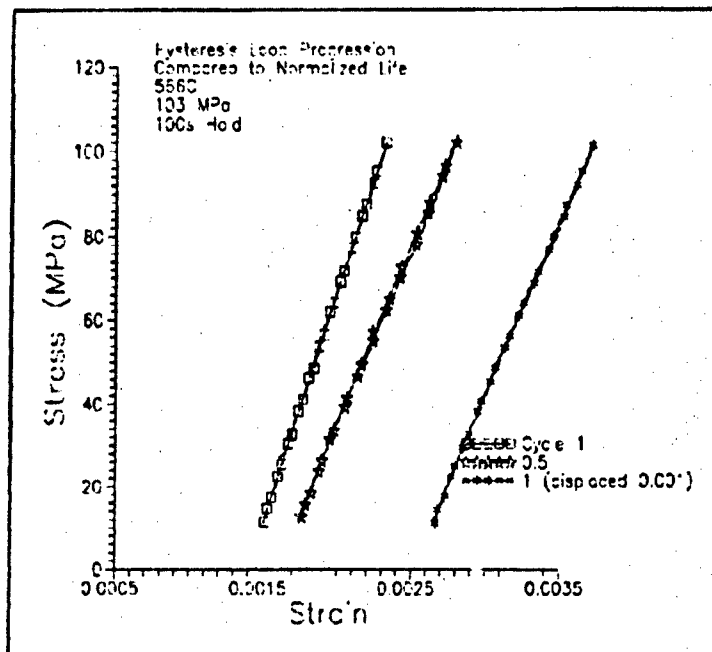
At 566°C/103 MPa, the curves show the tendency for an apparent decrease in slope with increasing hold time, however, the area traced by the loading and unloading curves does not change appreciably indicating a fairly constant rate of damage to the material. This is due to the level of stress in relation to the "knee" at 566°C. 103 MPa is well below this critical value at the lower temperature, and the damage on successive cycles is relatively small. These loading curves are shown in Figures 33 through 36.

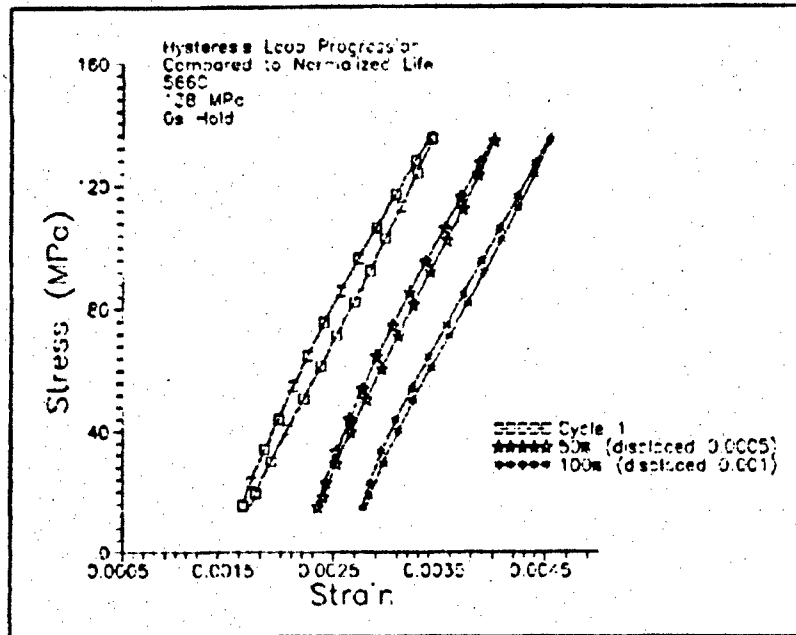
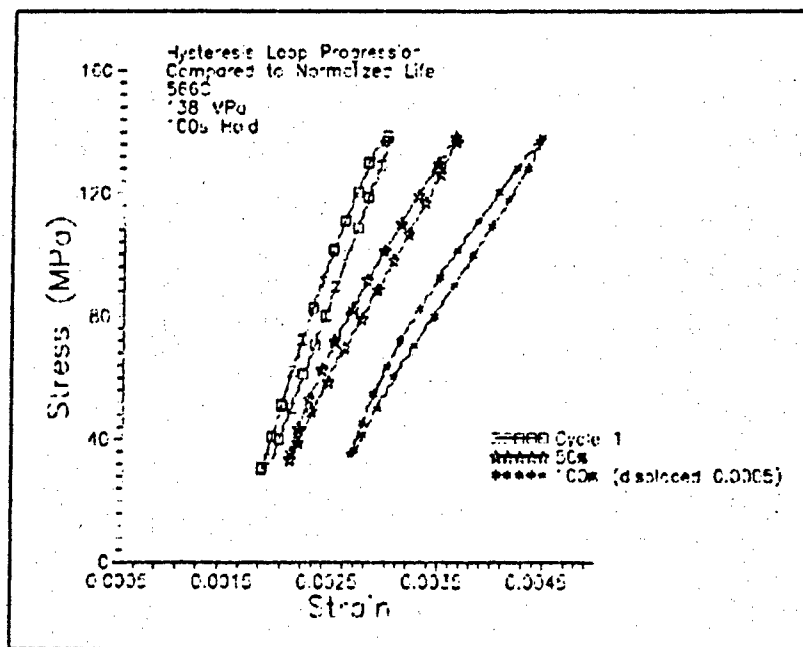
This is in contrast to the 138 MPa data which shows a large traced area on the initial cycle, followed by a decreasing area with successive cycles. Like the 103 MPa data, this data shows a tendency for slope decrease as the hold time increases. This is due to the stress at the "knee" being exceeded. At this level, the 90° plies are destroyed on the first few loading cycles (as evidenced by the area traced by the loading curves), and, after that, the curve area remains relatively constant to the point of failure. These loading curves are shown in Figures 37 through 40.

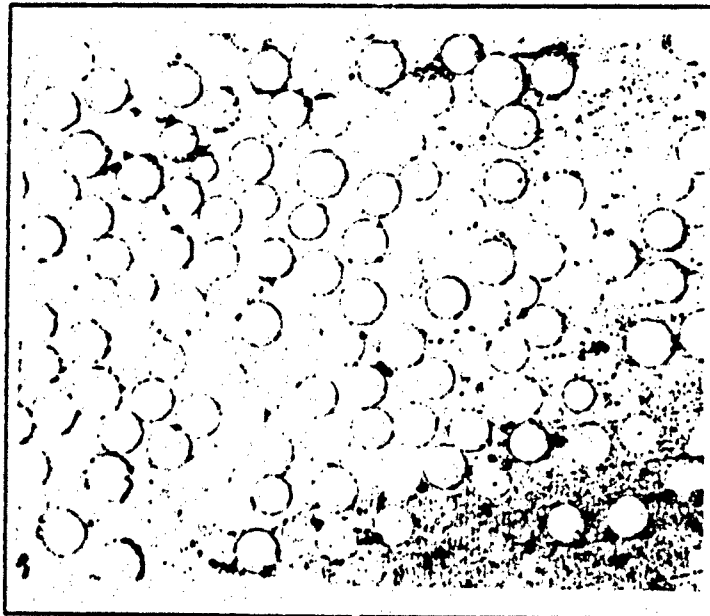
Figure 78. Combined Behavior, 40x.

Additionally, an optical microscopic analysis was performed on four of the specimens--each representing the ten second hold specimen of one temperature/stress regime contained in Table 4. It was found that brittle behavior was prevalent in the high temperature/low stress regime. This is illustrated by the crack in Figures 76 and 77. The crack appears to have a preferential direction that, when magnified further in Figure 77, reveals cracking through the fibers. This is indicative of a fully embrittled fiber-matrix interface. The high temperature, high stress specimen shown in Figure 78 illustrates a combined
